The 5th International Conference on Through-life Engineering Services (TESConf 2016)

Tensile Response of Adhesively Bonded Composite-to-composite Single-lap Joints in the Presence of Bond Deficiency

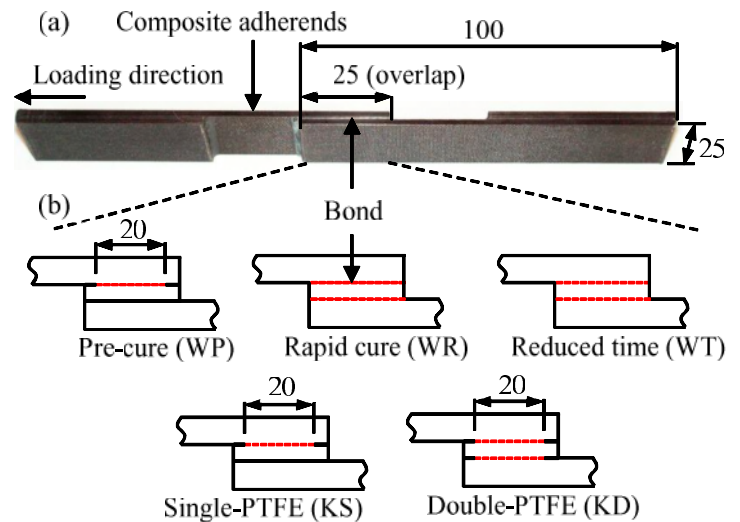
Figure 1. (a) Bonded joint geometry (all dimensions are given in mm); (b) schematic of weak bond categories (dashed lines represent regions where bond was weakened)

A 2mm-thickness carbon fibre-reinforced composite panel was manufactured from aerospace grade unidirectional Hexply® M21/T800S pre-preg using manual laying-up and autoclave cure, having the stacking sequence of $[0^\circ 90^\circ 45^\circ - 45^\circ]_s$. The joint laps were then extracted from the laminate using abrasive water jet technology (dimensions are given in Figure 1(a)).

Figure 1(b) schematically shows five modified categories with the dashed line representing the weak bonds. The PTFE films (categories KS and KD) were embedded at centre not the bond run-outs, to avoid pre-cracking. The WP category was then introduced to the centre to provide comparisons with the KS and KD cases.

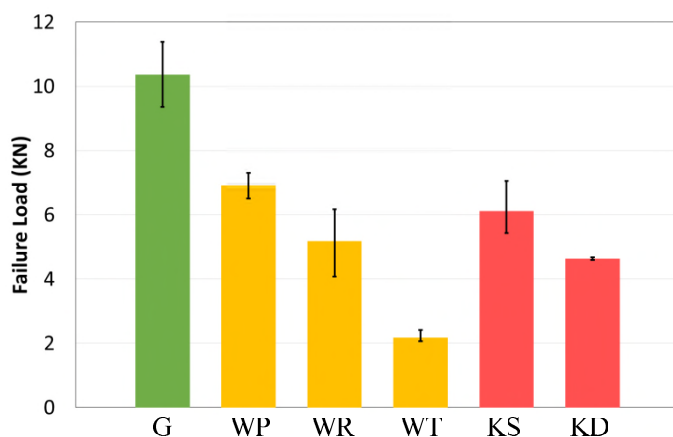
Figure 2. Comparison of failure loads in joints with different bond quality

Consistent data were obtained for each bond category, Figure 2. The KD (double-side PTFE) bond provided the most reproducible data, and WR (rapid cure) bond provided the largest spread in failure loads. The weak joint with the pre-cured bond (WP) represents an incomplete or partial curing scenario in actual bonded repair applications and is of greatest interest. The results in Figure 2 show that despite curing the centre prior to bonding the composite adherends, the joint has been able to sustain 67% of the failure load of the good bond (no defects). Whilst rapid curing using the temperature rate of 4°C/min, twice the specified rate, produced a bond which only reached 50% of the standard joint's failure load. This is approximately the same response as the joint with a double-side PTFE. Among all joint categories, the bonded joint with the reduced cure time exhibited with the greatest reduction (79%) in the failure load.

The images, figure 3, are consistent with the failure load results, figure 2. The pre-cured bond (WP) and the kissing bonds with PTFE films (KS) failed approximately at a same load and their failure mechanism appears to be similar, Figure 3. It should be noted that due to the unsymmetric bond area in the WP and KS categories, unsymmetric secondary bending is introduced, i.e. the composite adherend at the weak bond side undergoes higher bending strain.

Also of interest is the bond cured by rapid heating (WR). As seen, the morphology of the failure surface is different from the others. It has been observed that higher ramp rate could cause increased voids and increased variation in degree of cure due to temperature gradients throughout the bonded joint [14]. This significantly affects the bond and structural integrity. This category with the one with reduced curing time (WT) has both shown the lowest failure loads in Figure 2.

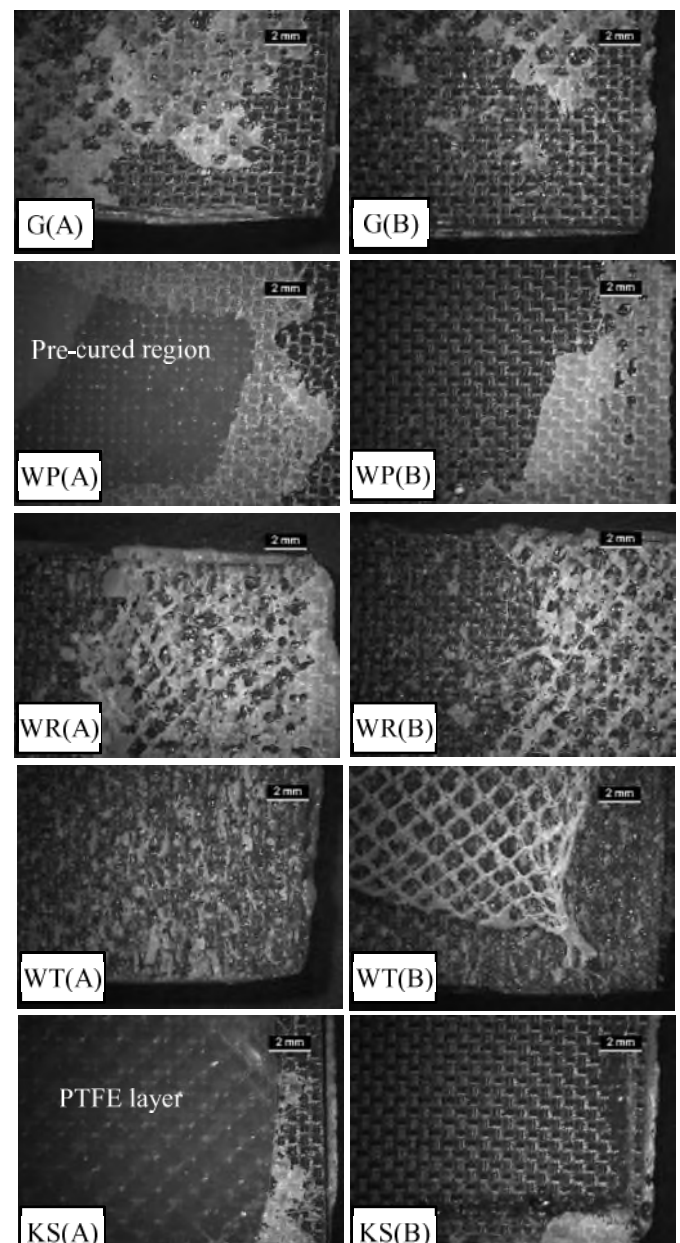
Figure 3. Microscopic images of the bonded joints after failure

All joints were observed to fail at the bond interface. The images from each adherend contact faces (A and B) of the bond of one representative joint from each category (except KD) are shown in Figure 3. Bright and dark regions represent the adhesive and the surface of the composite respectively. The images for the bonds incorporating PTFE film (KS and KD) were very similar and only images for the KS joint are presented. Any cohesive failure behavior of the adhesive was minor, with most joints exhibiting adhesive failure at the adherend/film adhesive interface. This was evident from the microscopic images in Figure 3 where the adhesive has been

observed bonded on one adherend only and peeled from the other. The only exception was the bonded joint cured in a time shorter than the others (WT), where a combination of interface and cohesive failure was observed. This is expected as in a

The adhesive films contain carrier cloth which, based on our observations, did not fail (see e.g. WT(B) in Figure 3), and thus is believed to be directing damage toward the interface. The bond thickness was relatively low (0.25mm) compared to the Standard [10] recommendation (0.76mm). This difference should reduce the joint eccentricity but the reduced thickness is expected to experience higher peel strain from geometry effects.

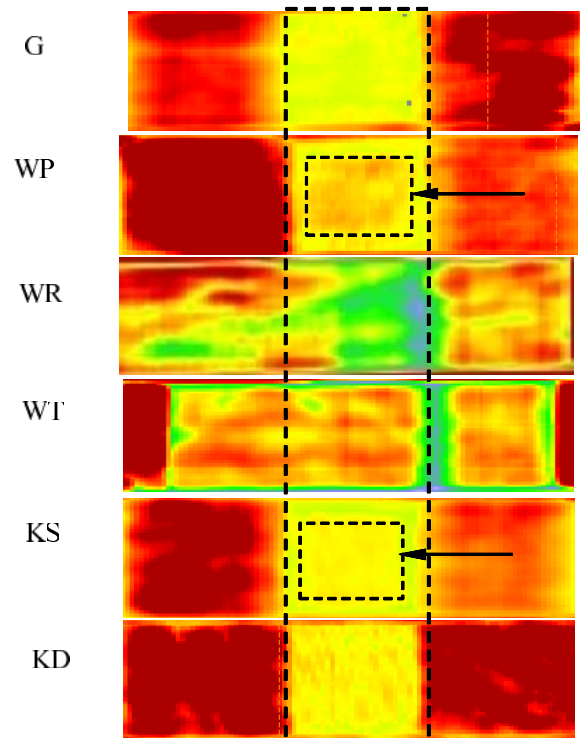
Figure 4. C-scan images of the bonded joints before test (outer dashed line represents the overlap bonded region of the joints (25mm×25mm) while inner dashed lines with arrows represents 20mm×20mm disbond at the centre of the overlap for WP and KS joints)

The C-scanned images of the joints' overlap region is shown in Figure 4, carried out using the parameters given in section 2.3 (the outer dashed line represents the overlap bonded region for all joints). Note that the C-scan images represents attenuation of a probe signal through the two composite adherends and the adhesive (bond). However as the significant difference is expected to arise from the adhesive (bond), and not in the adherends, the difference seen in the colour contours is referred to as defects. Taking the good bond with green/yellow contours as the reference for a bond with no defect, apparent differences observed for the rest of the joints are a sign of bond deficiencies. The WR and WT joints have also shown a clear mismatch and difference in the whole overlap region of the bond, compared to the image of the good bonded joint. This is in agreement with the results in Figure 2 where WR and WT had the most significant drop in failure load compared to the good bond. Clearly for the joint with reduced cure time, the C-scan is able to qualitatively capture the significant mismatch in the adhesion and bulk properties of the pre-maturely cured bond. Moreover, the main outcome from the figure is that the ultrasound technique clearly highlights the bond deterioration at the centre of the overlap region for WP (pre-cured bond) and KS (single-PTFE bond). This central region captured by NDI, shown by the arrows in the figure, represents the 20mm×20mm disband intentionally introduced at the centre of the overlap for WP and KS joints. Surprisingly, the disbond region is not observed for the KD joint which has

two PTFEs at either side of the bond. Understanding this requires further investigation.
